# 2019 Silver Hart Access Road Stream Crossing Assessments

**CMC Metals Ltd**

19Y0228  
October 2019

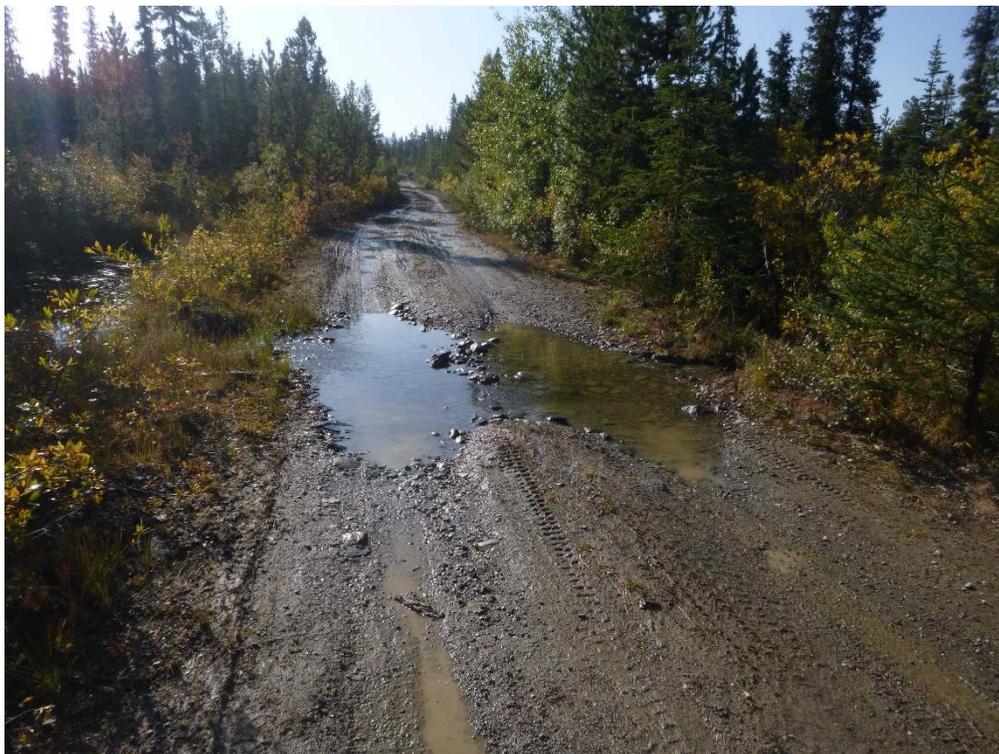
**Photo 1.** Water flowing over the road at Site 0 from the pond on the left (east) to the creek on the right (west).

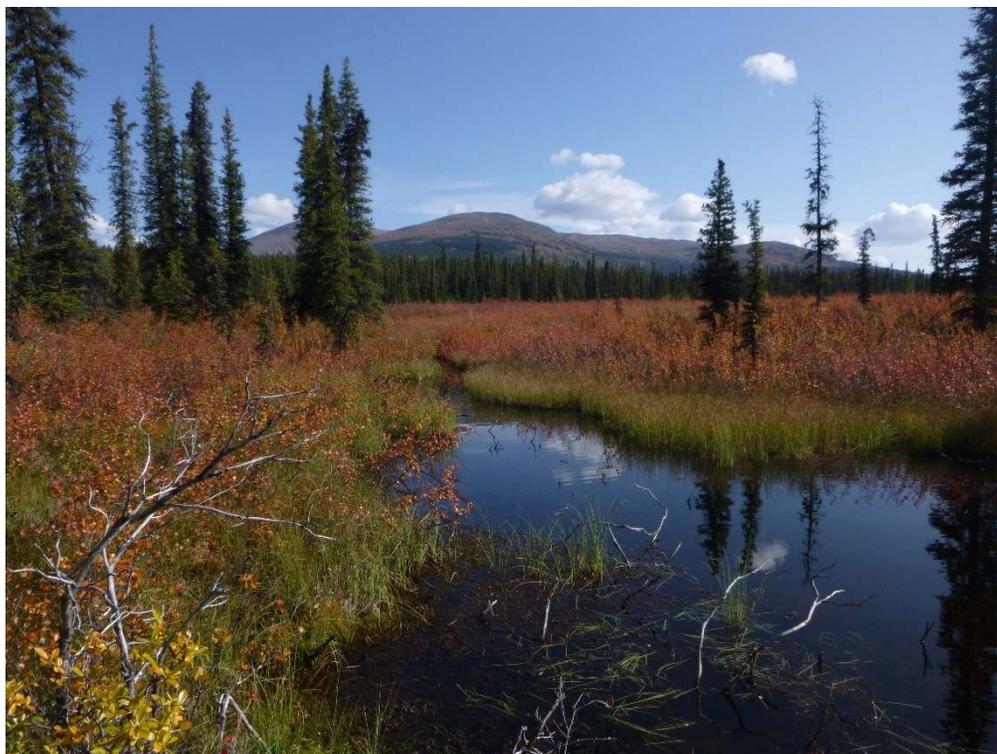
**Photo 2.** The wetland and pond at Site 0 immediately upstream (northeast) of the road.

The pond upstream of the road has an average depth of approximately 1.0 m and is approximately 0.3 ha in size. Because of the pond's small size, limited depth and low flow, the pond likely either freezes to bed or becomes anoxic during winter. Large amounts of organic material were observed in the pond, which would contribute to anoxic winter conditions. Due to the lack of connectivity between the creek at this crossing and watercourses either upstream or downstream, the results of fish sampling, and the lack of potential overwintering habitat this drainage has been determined to be non-fish bearing. Future work to install a culvert at this crossing should be designed in a manner to help maintain downstream water quality (i.e. complete work in the dry by pumping water over the road during culvert installation).

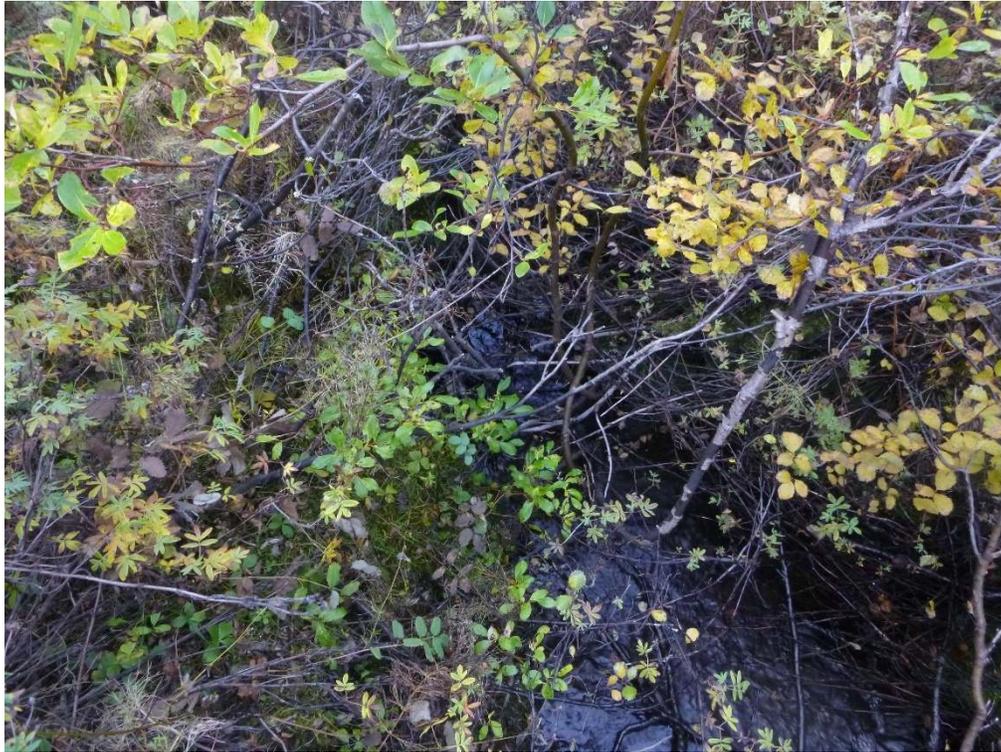
Photo 5. Poorly defined channel at Site 0 approximately 10 m downstream of the road.

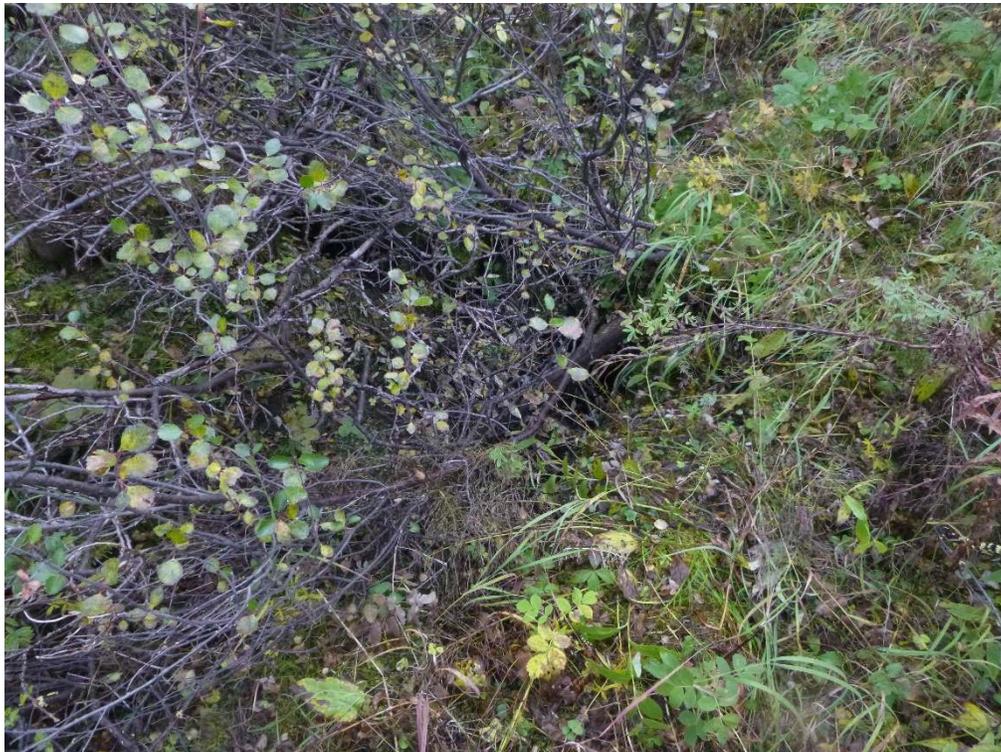
Photo 6. An example of where the creek flows underground at Site 0 where there is no visible stream channel.

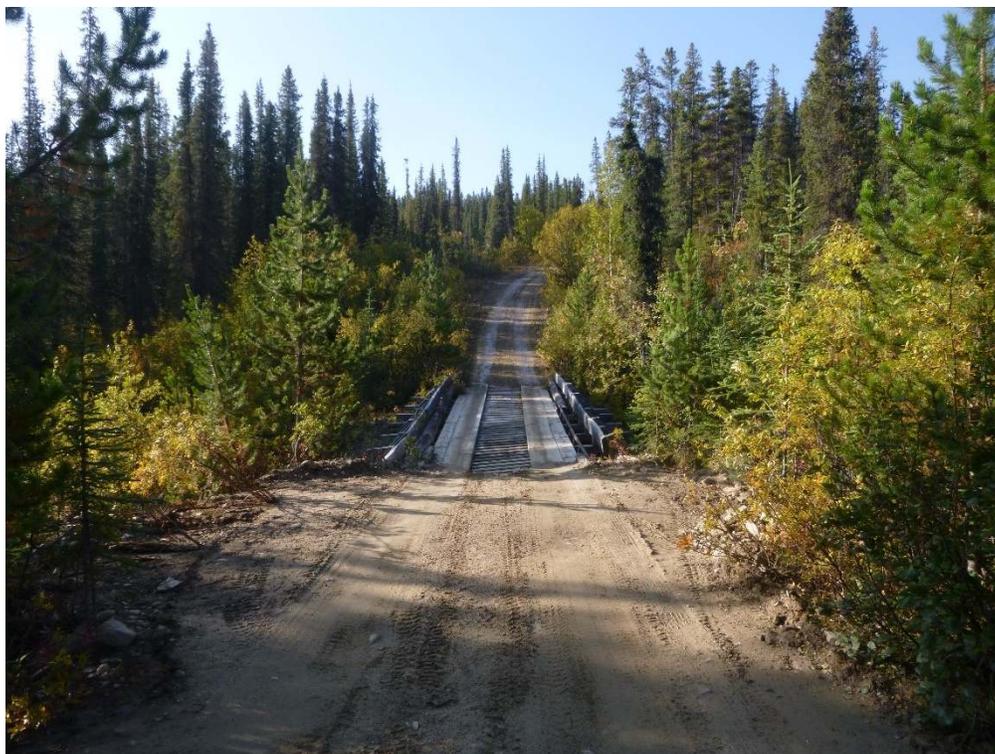
**Photo 8.** View of the bridge at Site 2 looking south. Note the slight slumping of the north side of the bridge on the left side of the photo.

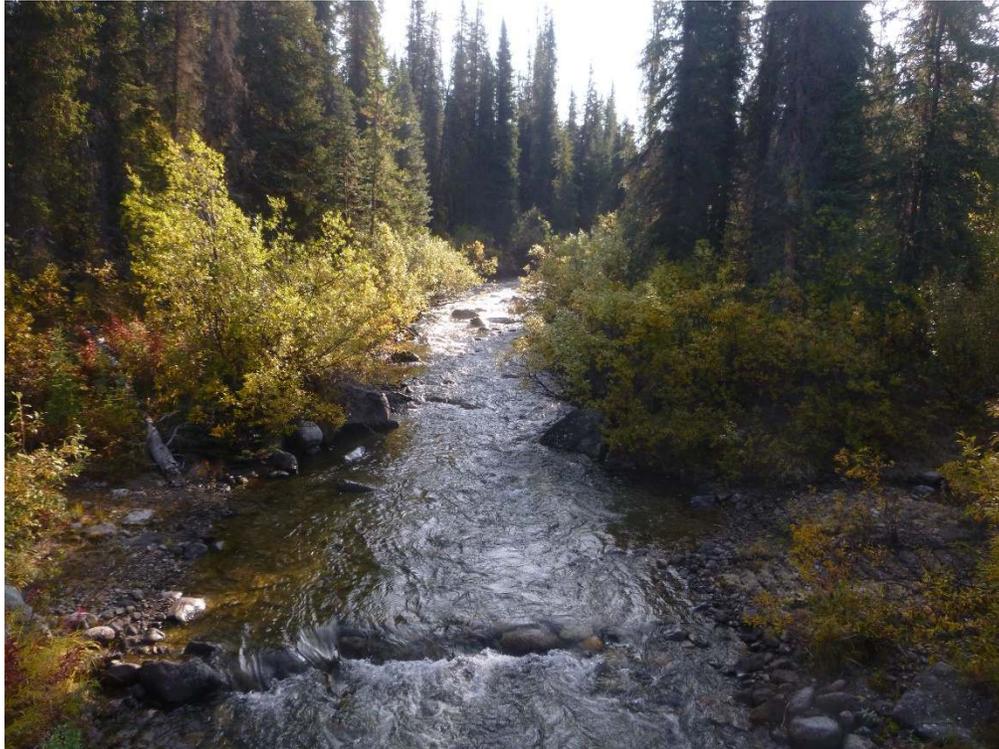
It is understood that the ford will continue to be used at the crossing for heavy equipment (Photo 9) as the bridge is too narrow to accommodate some vehicles. The streambed and stream bank materials are stable at the crossing and not easily erodible, with few fines present. The streambed is dominated by cobbles, and fast water velocities at and downstream of the ford limit spawning habitat potential. In addition, the entrance and exit to the ford crossing are stable and at a low angle. If the number of ford crossings is kept small and the riparian vegetation at the crossing is maintained the impact to water quality and fish should be minimal.

**Photo 9.** Upstream view at Site 2 from the bridge showing the location of the ford.

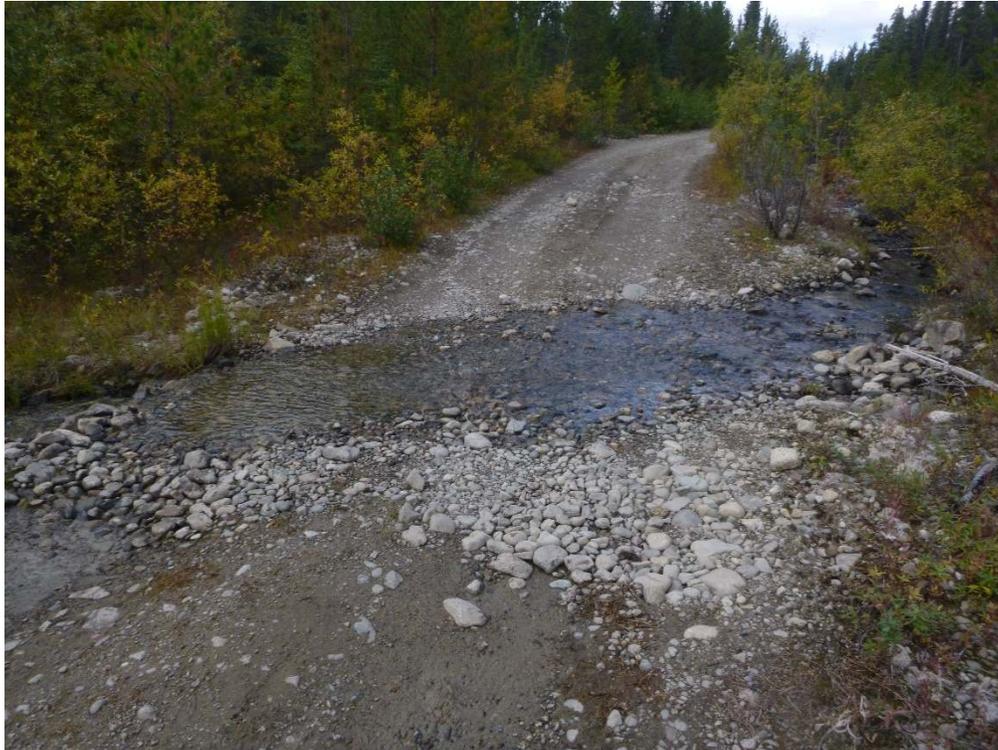
Photo 10. Water flowing over the access road at Site 2B.

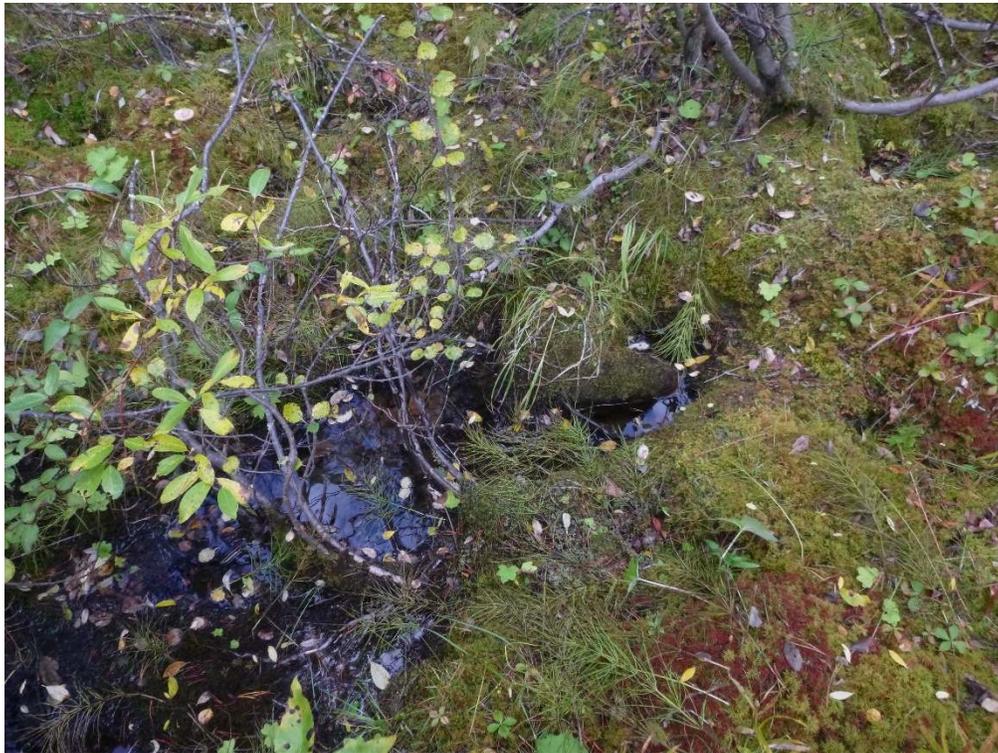
**Photo 13.** Downstream of the crossing the volume of water in the creek decreases and flows underground.

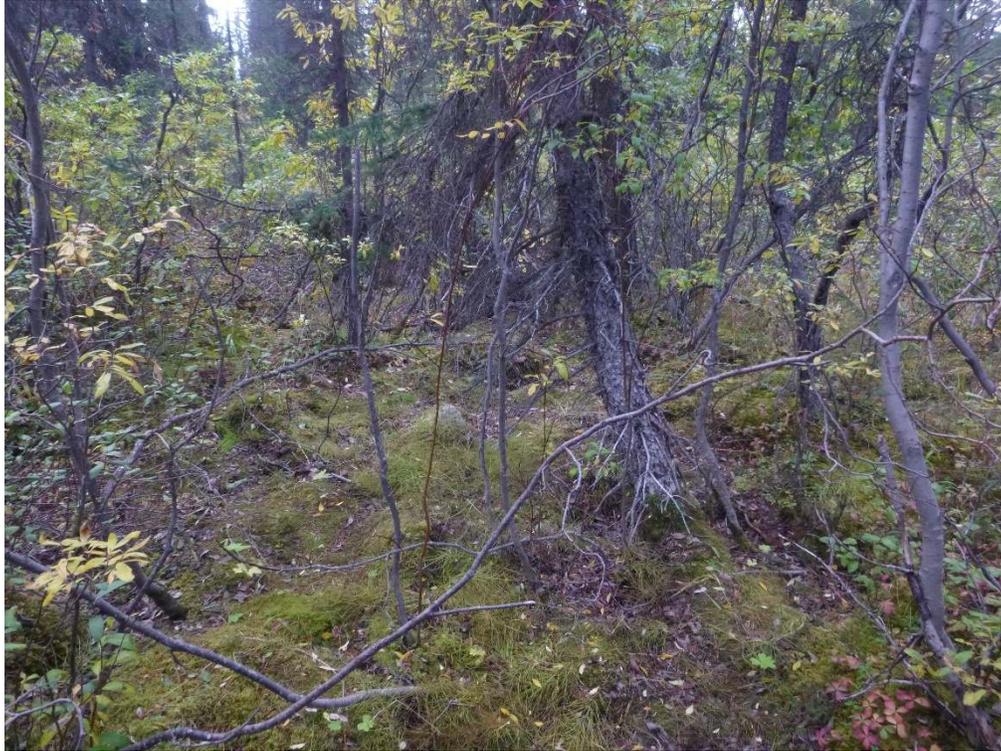
Photo 14. Downstream of the crossing where the drainage flows underground with limited evidence of surface flow.

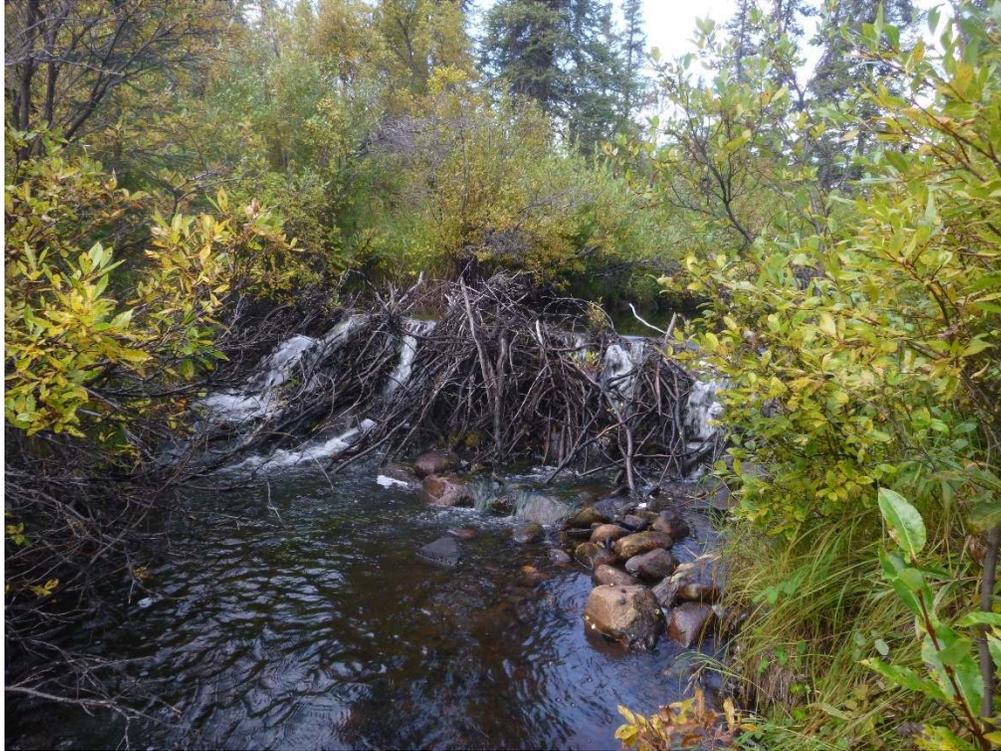
Photo 16. Beaver dam approximately 40 m upstream of the crossing.

The beaver dams investigated during this crossing assessment may temporarily limit the upstream movement of fish; however, these are dynamic systems and dams deteriorate over time. Dams may degrade due to high water events such as flooding and spring freshet; or winter processes such as ice scour and overflow. The pond located downstream, and additional ponds upstream of the crossing, provide potential overwintering and rearing habitat. Because the stream at this crossing is located less than one kilometer upstream of the Rancheria River, contains rearing and overwintering habitat, and has no permanent barriers to fish passage, the stream at this crossing should be considered fish-bearing.

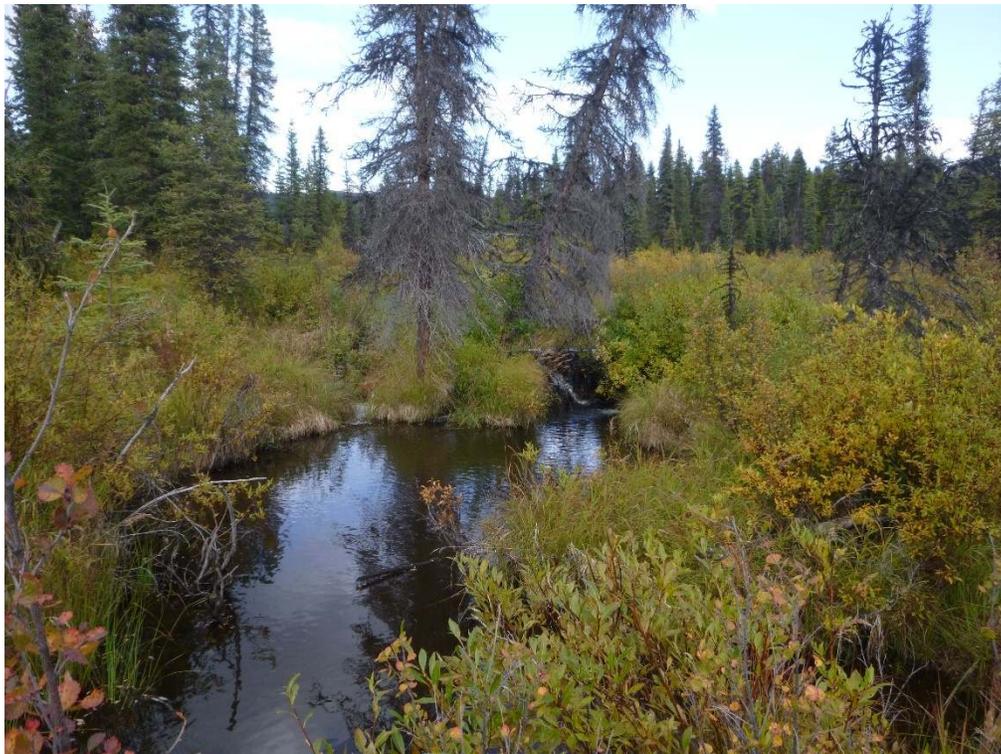
Photo 17. Small beaver dam approximately 35 m downstream of the crossing.

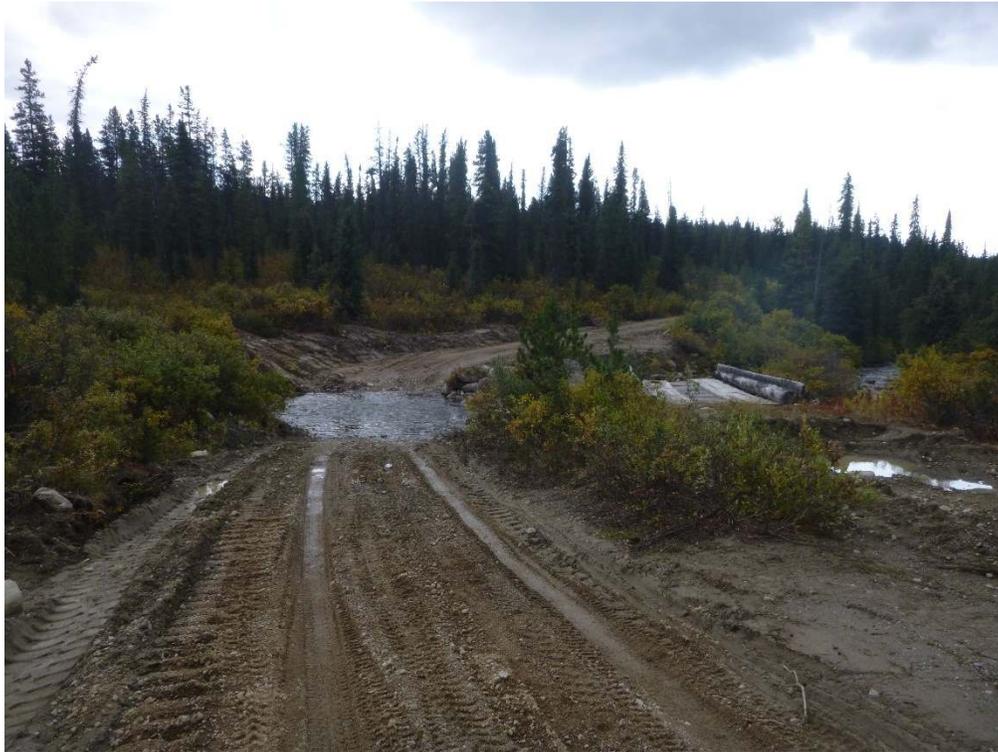
**Photo 19.** The current ford stream crossing at Site 5.

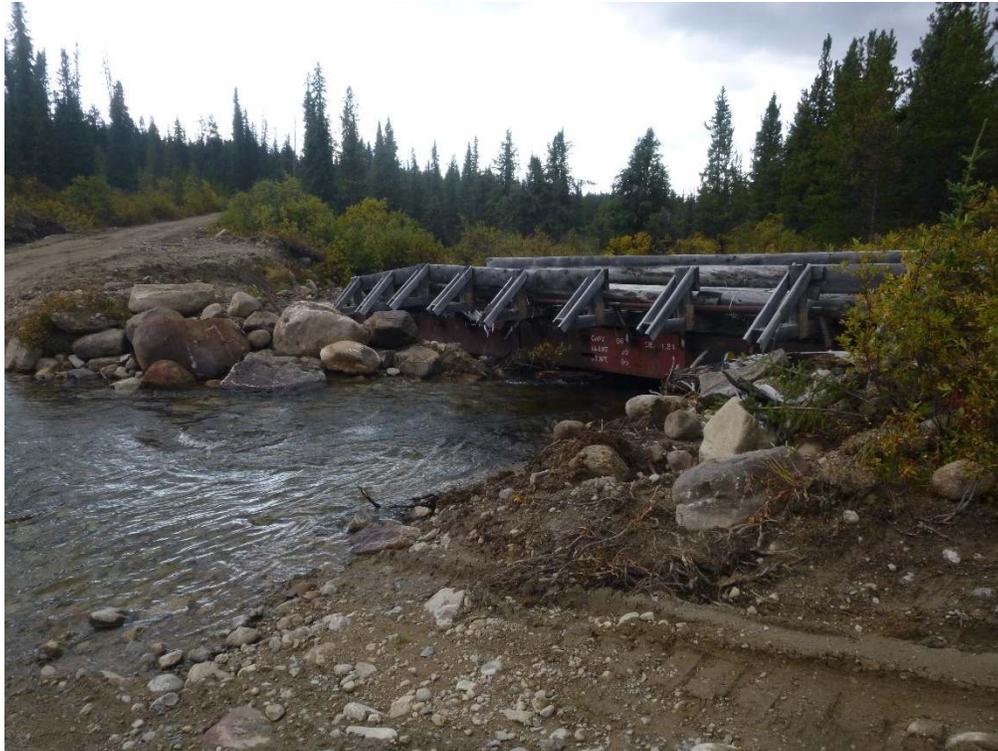
Photo 20. The washed-out bridge at Site 5 just downstream of the ford crossing.

Future work to lift and re-install the currently washed out bridge at this crossing should implement the following suggested mitigation measures to protect fish and fish habitat at the crossing.

- Complete work to armour the streambanks in the dry, or in isolation from the stream flow.
- If instream work is required, it should be completed between June 15<sup>th</sup> and Sept. 1<sup>st</sup>, the freshwater timing window identified by DFO

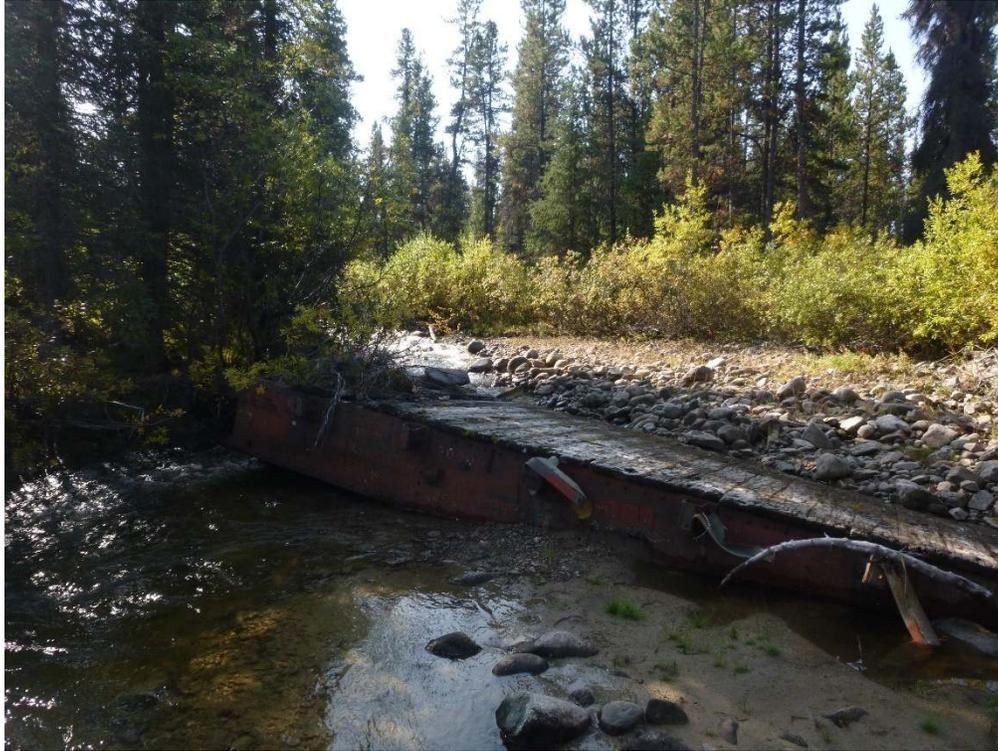
A bridge was previously installed at the crossing but has since been washed 50 m downstream (Photo 27). There was some mention of the possibility of re-using this structure at the crossing. If this option is pursued some mitigation measures to protect fish and fish habitat specific to the excavation of the bridge should be implemented. These include all of the measures mentioned above, in addition to the following.

Photo 27. The washed-out bridge 50 m downstream of the crossing and partially buried by fluvial material.

- Complete the work during low flows and within the instream work windows (June 15<sup>th</sup> and Sept. 1<sup>st</sup>).
- Have a qualified environmental monitor (EM) on-site during extraction to refine a removal plan, monitor instream turbidity, and implement an access plan that minimizes disturbance to the stream and riparian vegetation.

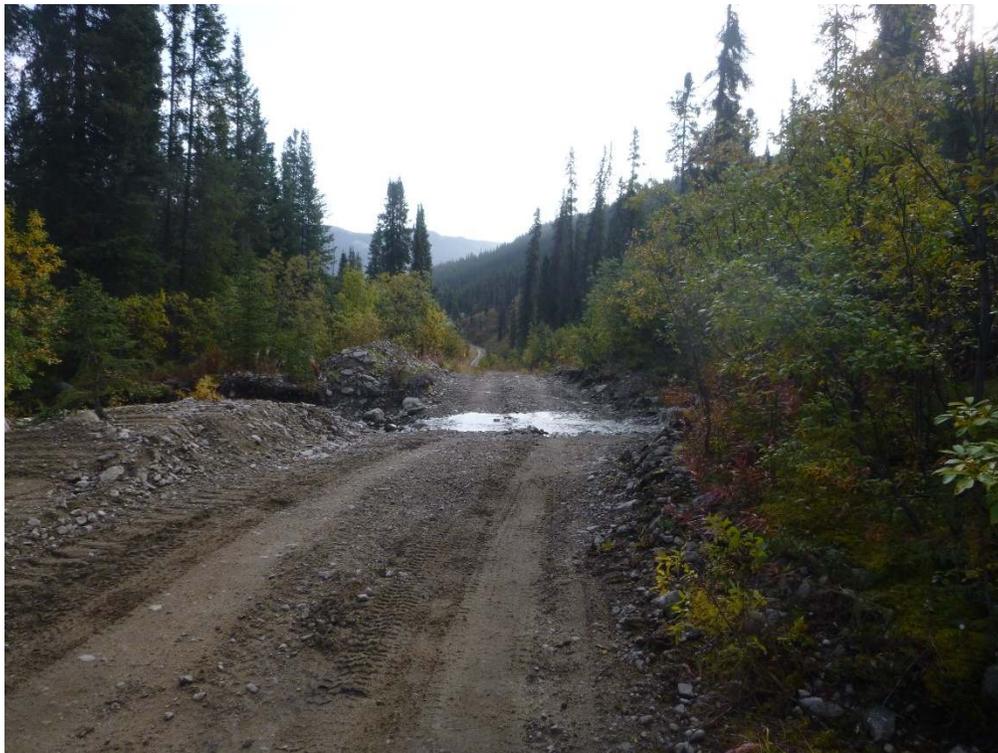
Photo 28. View of the ford crossing at Site 10, with the creek flowing over the road.

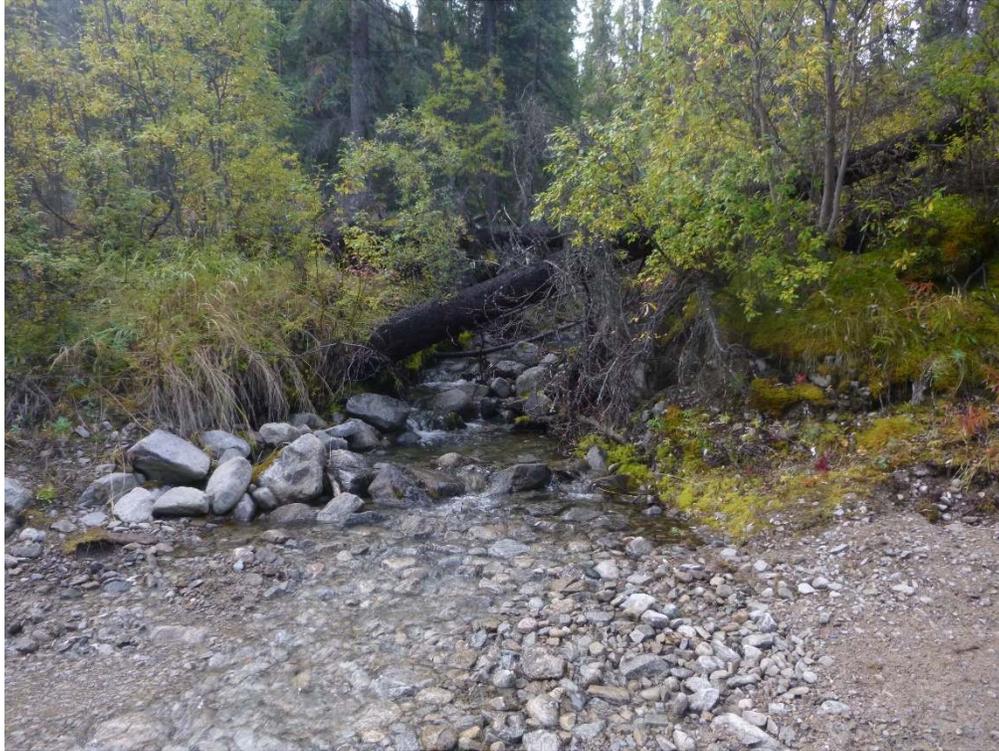
Photo 29. Upstream view of the creek flowing onto the road at Site 10.
