# 2019 Silver Hart Access Road Stream Crossing Assessments

**CMC Metals Ltd**

19Y0228  
October 2019

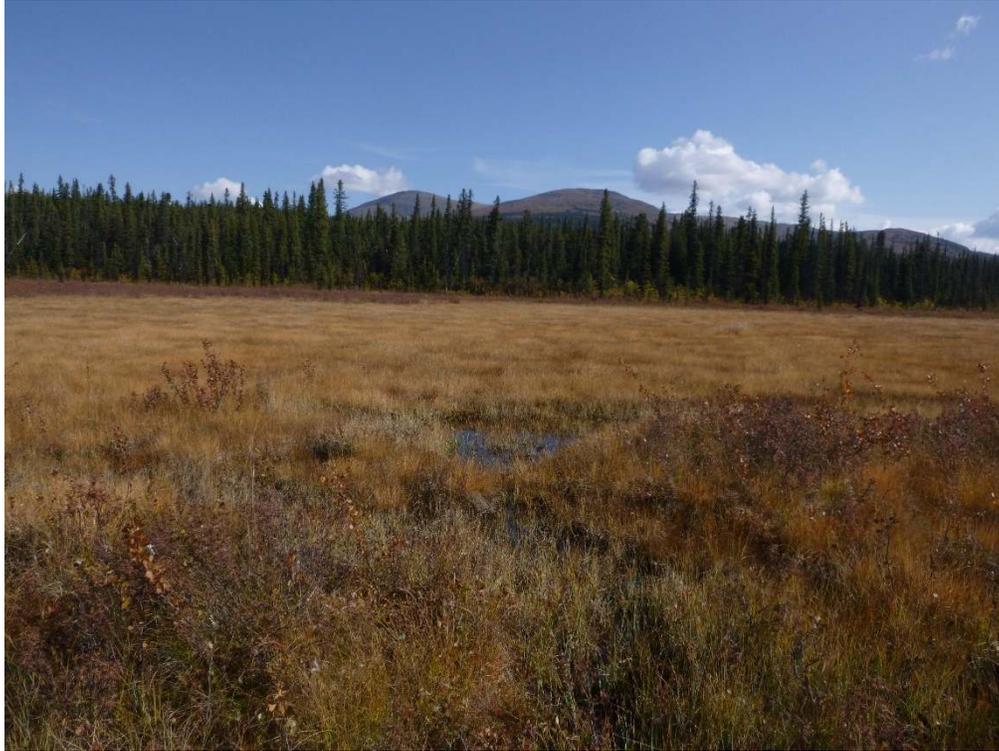
Photo 3. The terminal fen up gradient from road and pond at Site 0.

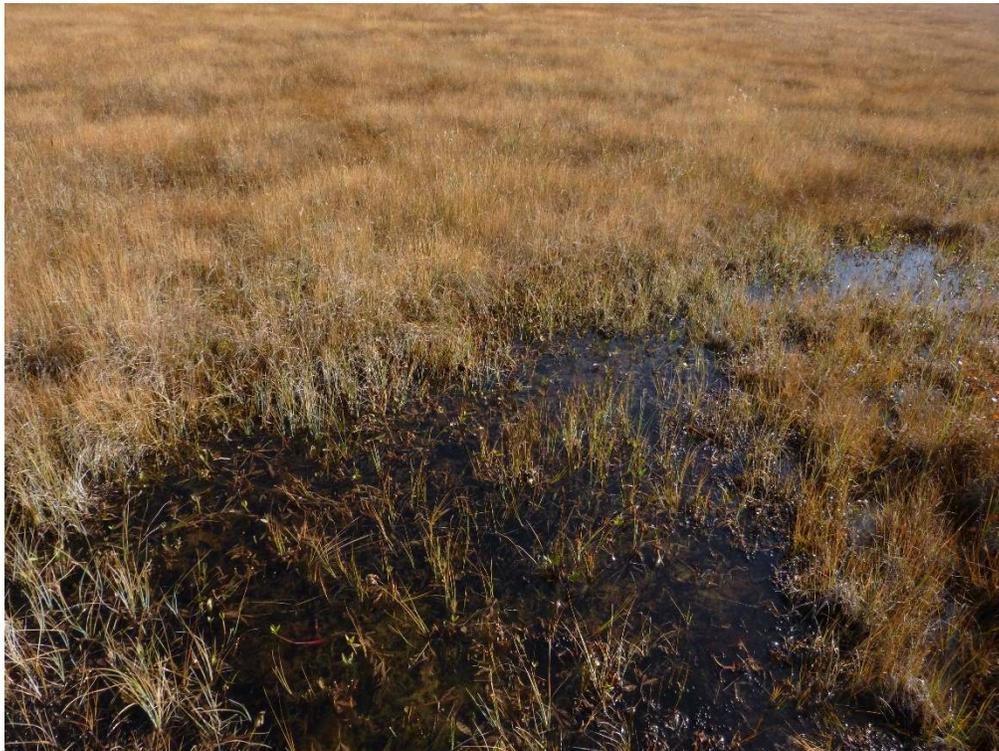
Photo 4. Detailed view of the upstream terminal fen, where the stream starts flowing on the surface.

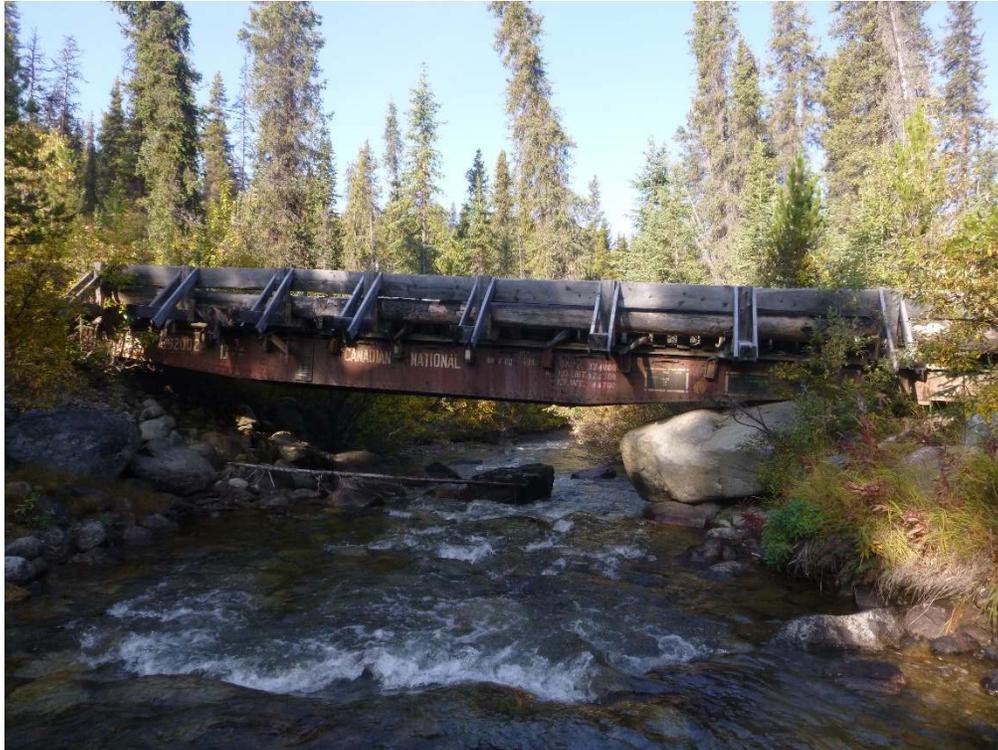
Site 2 is located on Goat Creek approximately 12.2 km up the Silver Hart access road (Photo 7); there are a number of lakes upstream of this crossing including Goat Lake (Map 2). The site is characterized by a mostly intact bridge that has one corner slumping slightly due to erosion (Photo 8). At this crossing Goat Creek is of moderate size, with an average bankfull width of 6.91 metres and abundant instream cover provided by boulders, undercut banks, and deep pools. Moderate habitat complexity exists near the crossing including numerous pools, riffles, runs, cascades, and some off-channel habitat.

**Photo 7.** Downstream view of the bridge at the Site 2 crossing from Goat Creek.

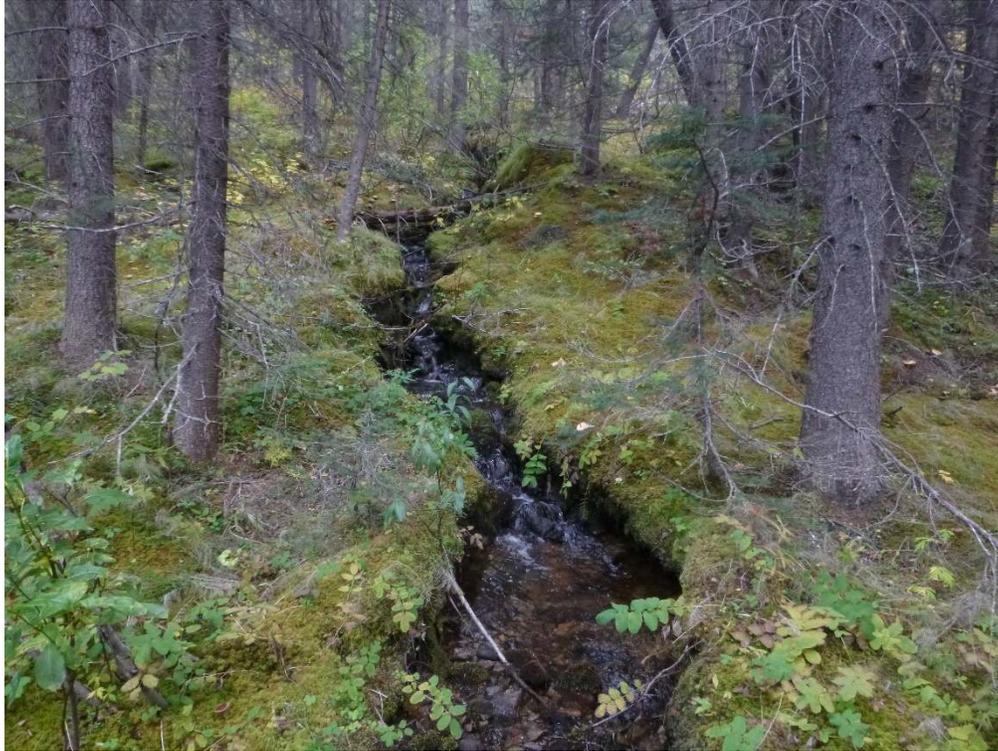
Photo 11. Upstream view of the stream 200 m upstream of the road crossing.

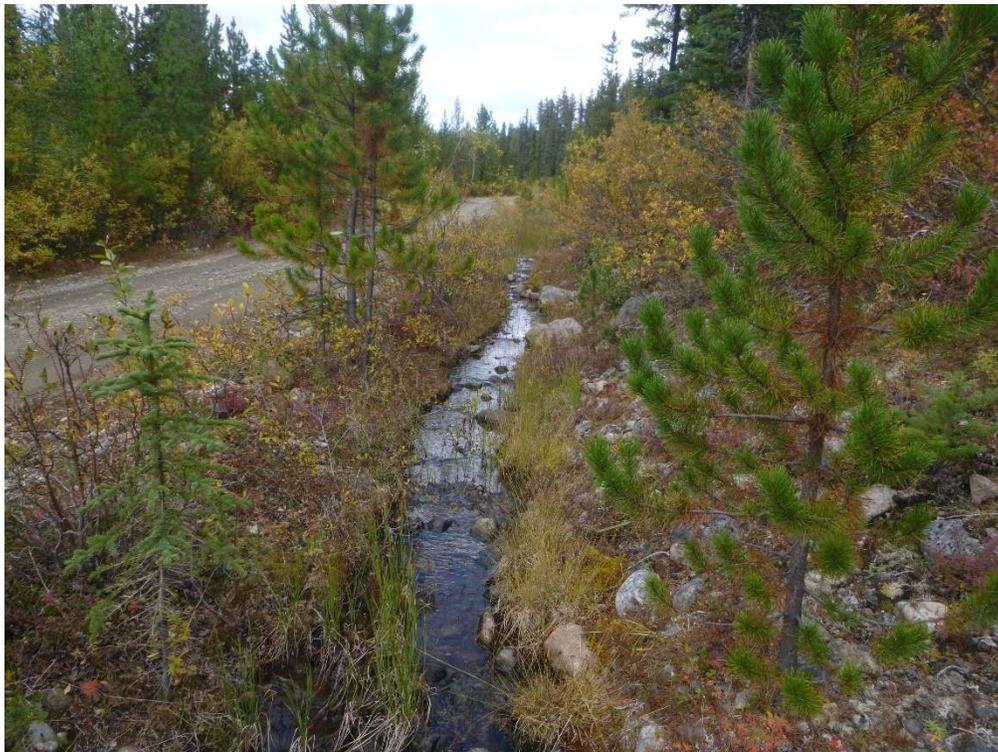
Site 2B is located on an unmapped drainage (CanVec 1:50,000) approximately 13.5 km up the Silver Hart access road. The site is a small creek that connects to the road and flows for 100 m in the ditch before flowing over the road (Photo 10). The creek is consistently narrow and confined, with an average bankfull width of 0.5 m, and contains very little habitat complexity. The creek bed is primarily comprised of cobbles and gravels (Photo 11), and varies in gradient from five to fifteen percent in the forest before connecting to the ditch (Photo 12).

Photo 12. The creek flows in the ditch for 100 m upstream of the crossing.

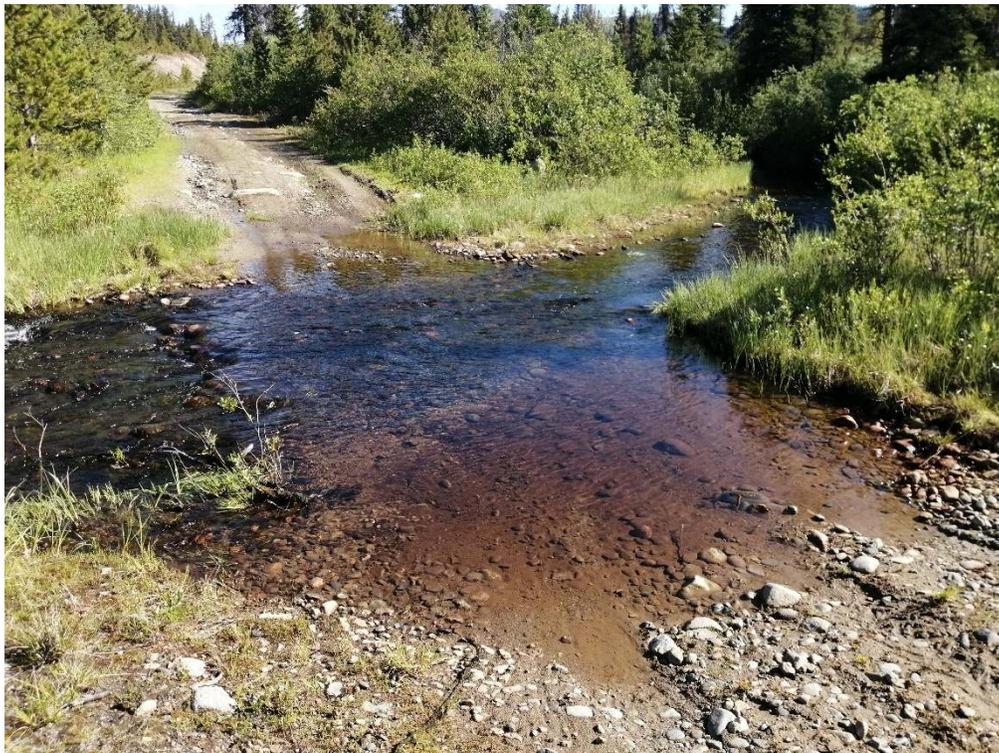
Site 3 is located approximately 14.8 km up the Silver Hart access road (Photo 15). The site is characterized by a stream with numerous beaver dams upstream and downstream of the crossing (Photo 16 and Photo 17). One beaver dam was identified upstream of the crossing, and two were identified downstream during the assessment. The stream near the crossing has an average bankfull width of 2.53 m. The streambed is comprised of cobbles and gravels covered in a thick mat of algae. Approximately 60 m downstream of the crossing is a pond (Photo 18) created by a large beaver dam that is currently an impediment to upstream fish movement (barrier 1.2 m - 1.6 m in height). Upstream of the crossing the stream flows in a well-defined channel, whereas downstream of the crossing the stream flows into the pond in multiple braided channels through willow and sedge tussocks.

**Photo 15.** The crossing at Site 3 (photo provided by Kevin Brewer).

- Culvert needs to be sized so it does not constrict the stream channel (>2.5 m diameter) and embedded to ensure fish passage.
- Divert water during construction to install the culvert in the dry.
- Limit disturbing surrounding riparian vegetation to maintain bank stability.
- Install appropriate erosion and sediment control measures.
- Complete work between June 15<sup>th</sup> and Sept. 1<sup>st</sup>, the freshwater fish timing window identified by DFO.

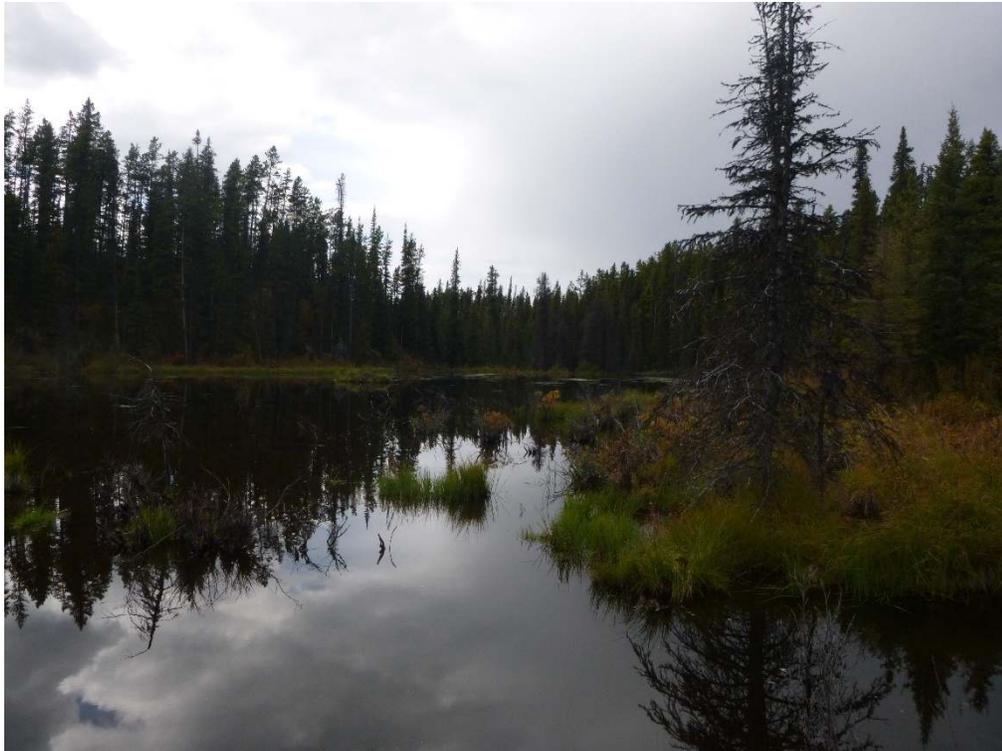
The beaver dams investigated during this crossing assessment may temporarily limit the upstream movement of fish; however, these are dynamic systems and dams deteriorate over time. Dams may degrade due to high water events such as flooding and spring freshet; or winter processes such as ice scour and overflow. The pond located downstream, and additional ponds upstream of the crossing, provide potential overwintering and rearing habitat. Because the stream at this crossing is located less than one kilometer upstream of the Rancheria River, contains rearing and overwintering habitat, and has no permanent barriers to fish passage, the stream at this crossing should be considered fish-bearing.

Photo 18. The pond created by an old, large beaver dam downstream of the crossing looking west.

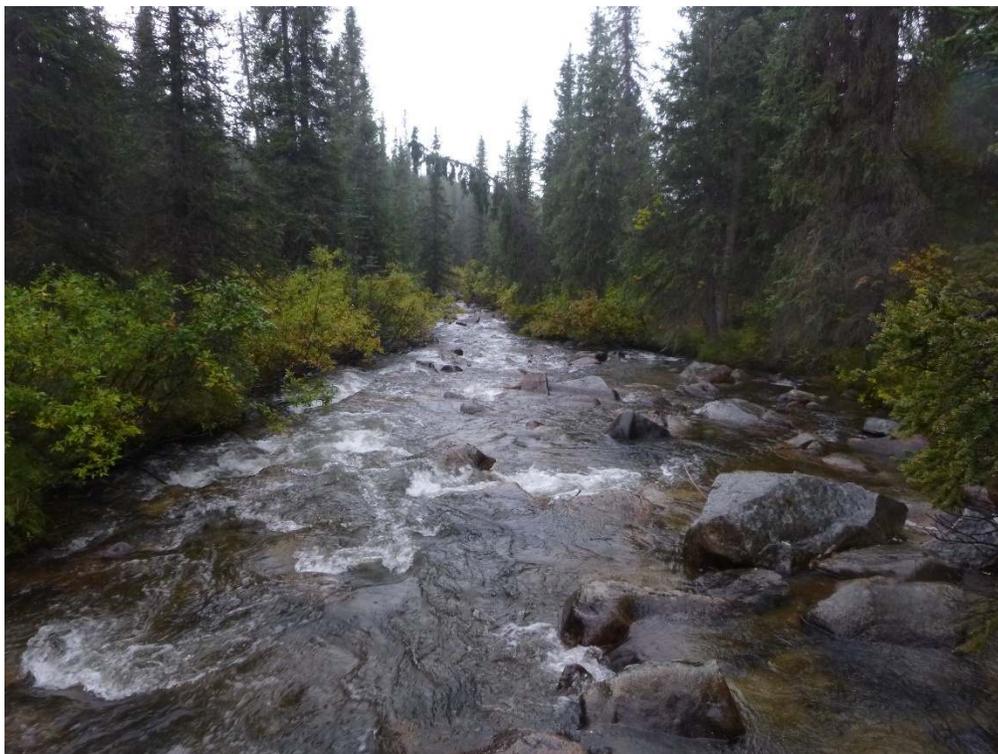
The stream at this crossing contains moderate habitat complexity with some areas of moderate slope (12.5% gradient) comprised of small cascades and steep riffles (Photo 21). This is a relatively high energy system at higher water levels as is evident by the washed-out bridge, and a streambed comprised of boulders and cobbles. Instream cover is primarily provided by boulders in addition to overhanging vegetation, undercut banks, and some pools.

Photo 21. Example of stream habitat downstream of the crossing at Site 5.

- Complete work to armour the streambanks in the dry, or in isolation from the stream flow.
- If instream work is required, it should be completed between June 15<sup>th</sup> and Sept. 1<sup>st</sup>, the freshwater timing window identified by DFO

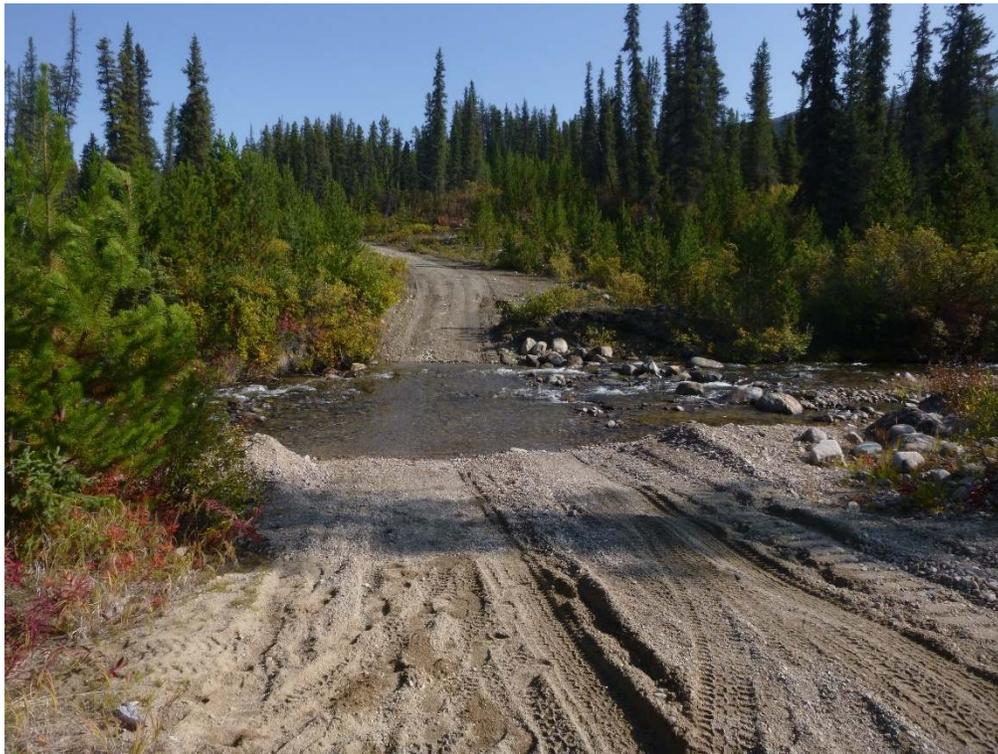
Site 9 is located at approximately KM 24.5 of the Silver Hart access road (Photo 24). The site crosses a low gradient stream (1.5%) of moderate size, with an average bankfull width of 6.53 metres. Currently, the crossing is forded by local traffic, with a low gradient approach from the south, and a steeper approach from the north. The streambed material is comprised primarily of cobbles and gravels, with some boulders present throughout. Moderate instream cover is provided by overhanging vegetation, and to a lesser extent undercut banks, deep pools, and instream vegetation. Good habitat complexity exists with well-defined riffles, pools, and glides evenly distributed throughout the regularly meandering stream (Photo 25 and Photo 26)

**Photo 24.** The crossing at Site 9 looking north.

- The crossing structure should be sized to accommodate the bankfull width of the stream and not reduce the width of the stream at the crossing (here approximately 6.5 metres).
- If a bridge is installed, construction of bridge footings or supports should occur isolated from the streamflow.
- Any instream work should be scheduled to be completed between June 15<sup>th</sup> and Sept. 1<sup>st</sup>, to coincide with the freshwater fish timing windows identified by DFO.

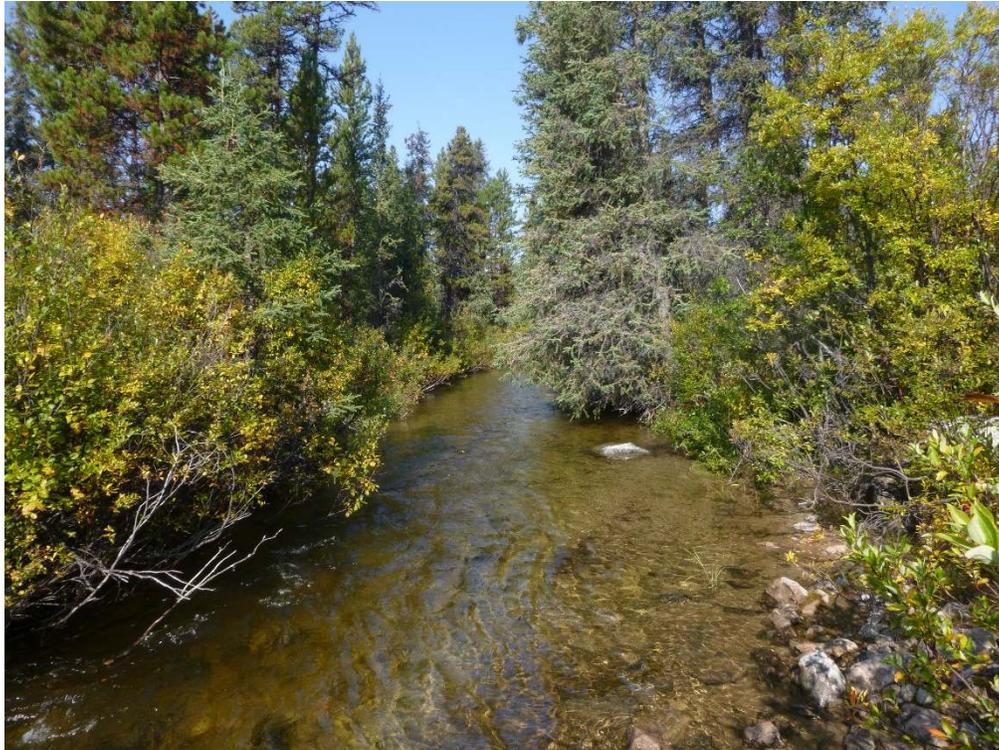
**Photo 25.** Downstream view of instream habitat immediately downstream of the crossing at Site 9.

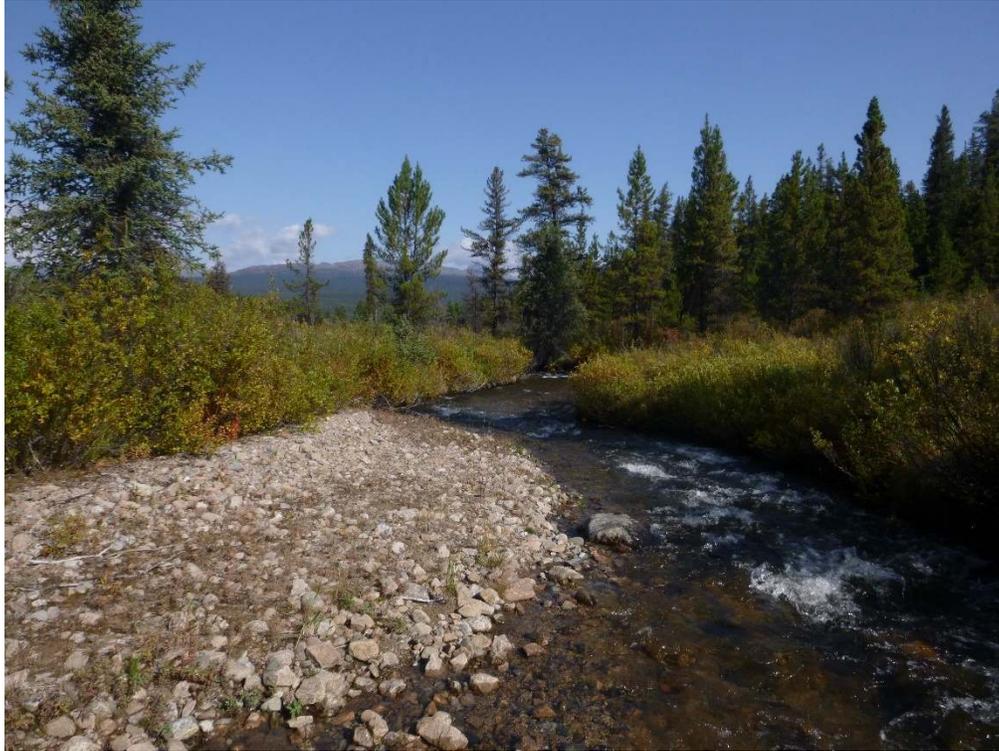
**Photo 26.** Downstream view of stream habitat approximately 100 m downstream of the crossing at Site 9.

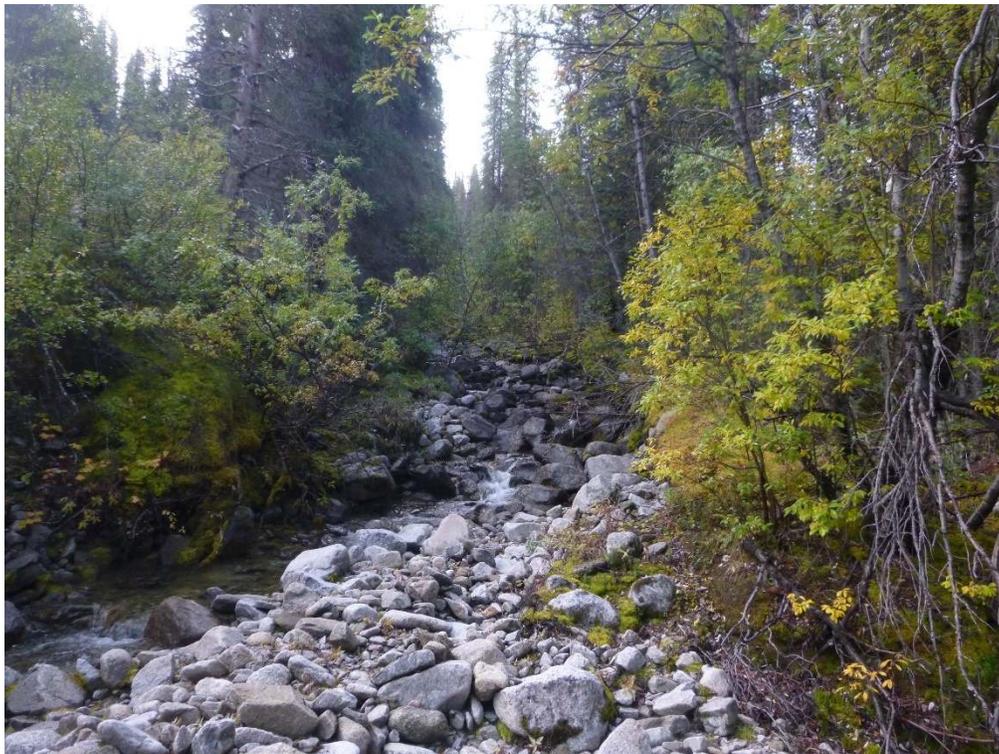
Photo 30. A view of the creek at Site 10 looking upstream a short distance up from the road.

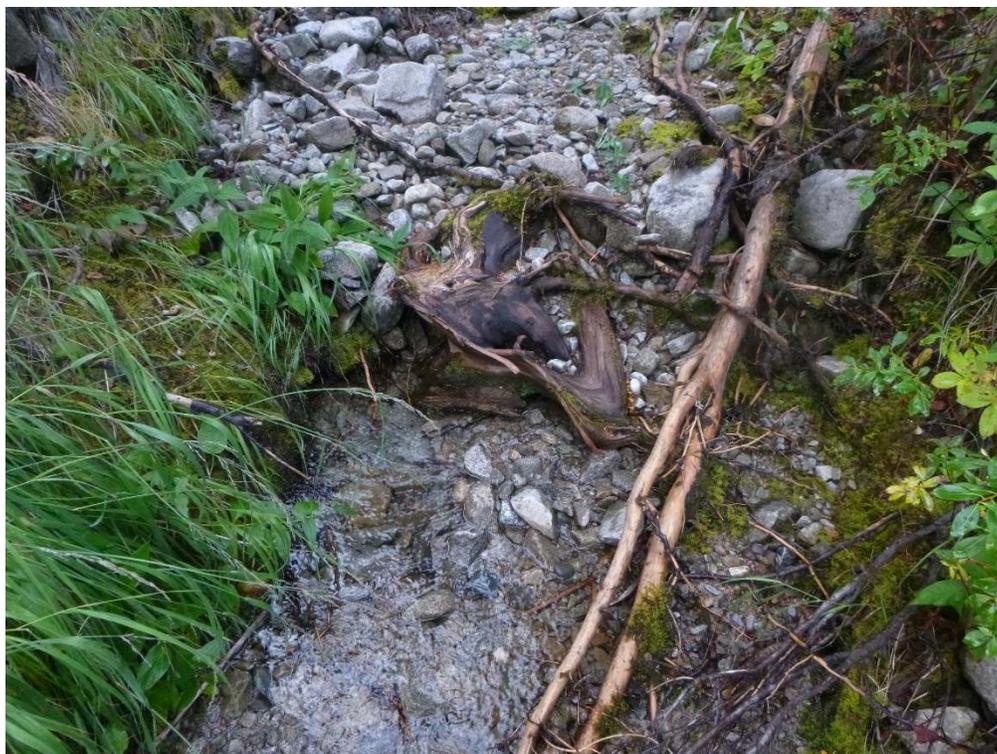
**Photo 31.** View of the lower portion of the dry section of the channel (top of the photo) as the creek re-emerged as surface flow immediately upstream of the lake.
